August 23, 2006

Re Site
Town 01234

REPORT SUMMARY

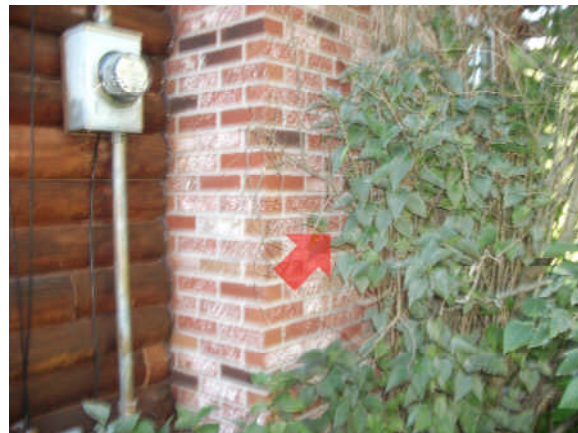
Maintenance needed. Trim plants away from structure. There are vines growing on the building. These can lead to premature failure of masonry and siding. Remove the vines from the building.

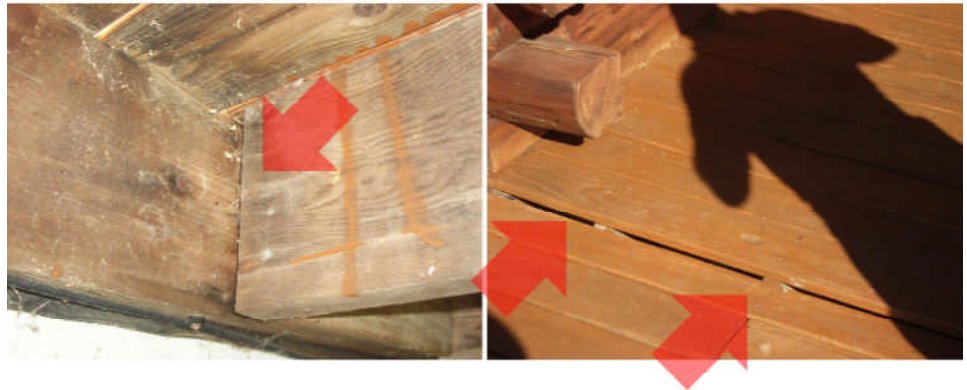
Deterioration noted to deck surface. Improper conditions viewed. There are irregular surfaces meeting on the decking. This raised and settled surface presents tripping hazards. The deck is nailed to the home. I recommend adding galvanized lag bolts every 32 inches to help stabilize the structure. I recommend adding joist hangers to the structure of the deck. It is impossible to determine if there is proper flashing installed. Contact a licensed contractor for further evaluation and recommendations.
